TEST REPORT

Report Number	0605	Report Date	21 / 02 / 2006
Client	ETEM S.A. LIGHT METALS COMPANY 1, IROON POLYTEHNIUO STR. GR 190 18 MAGOULA ATTIKIS GREECE		
Specimen description	Curtain Wall Specimen With four fixed elements System E – 8000 SEMI-STRUCTURAL External dimensions 2230 x 1835 mm <i>(code E02 0106 04)</i>		
Delivery Date	26 / 01 / 2006		
Conducted Tests	Air permeability – Watertightness Resistance to wind load		
Date of tests	01 / 02 / 2006		
<p>Notes : Twenty five (25) original pages in Greek with the constructional data of the specimen which has been tested are attached, as they were given by the client. No further verification of the above mentioned data has been conducted by E.K.AN.AL.</p> <ul style="list-style-type: none"> ➤ The choice of the specimen has been made by the client. <p>❖ THE RESULTS CONCERN ONLY THE SPECIMEN TESTED.</p> <p>❖ THE PRESENT DOCUMENT DOES NOT CONSIST PRODUCT APPROVAL BY E.K.AN.AL.</p>

Report Number	0605 / 1	Report Date	21 / 02 / 2006
Conducted Tests & Technical Standards AIR PERMEABILITY (EN 12153 / 2000 & EN 12152 /2004)		Testing Date 01 / 02 / 2006	
Laboratory Equipment

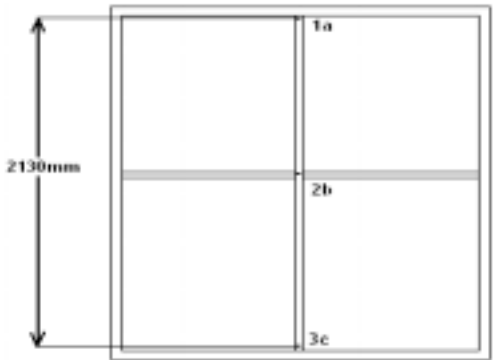
Positions of way transducers 1a, 2b and 3c.			
2. Air permeability (follow up) The air permeability of the specimen was not at all on the increase.

RESULTS					
1a. Frontal Displacement – Deflection (Positive pressures up to +3000 Pa)					
Pressure (Pa)	Sensor 1a	Sensor 2b	Sensor 3c	Frontal deflection $b - ((a+c)/2)$	Relative Frontal deflection (l=2130mm)
750	-0.3	-1.3	-0.4	-1.0	1/2130
0*	0.0	0.0	0.0	0.0	0
1500	-0.7	-3.1	-0.9	-2.3	1/926
0*	0.0	0.0	0.0	0.0	0
2250	-1.6	-5.5	-2.1	-3.7	1/576
0*	0.0	0.0	0.0	0.0	0
3000	-1.5	-6.9	-3.6	-4.4	1/484
0*	0.0	0.0	0.0	0.0	0

* (after 60s)					
1b. Frontal Displacement – Deflection (Negative pressures up to -3000 Pa)					
Pressure (Pa)	Sensor 1a	Sensor 2b	Sensor 3c	Frontal deflection $b - ((a+c)/2)$	Relative Frontal deflection (l=2130mm)
-750	0.5	1.6	0.7	1.0	1/2130
0*	0.0	0.0	0.0	0.0	0
-1500	1.1	3.4	1.6	2.1	1/1014
0*	0.0	0.0	0.0	0.0	0
-2250	1.8	5.5	2.5	3.4	1/627
0*	0.0	0.0	0.0	0.0	0
-3000	2.6	7.7	3.4	4.7	1/453
0*	0.0	0.0	0.0	0.0	0
